Manhole Inspection Summary

Manhole # S35UU_008MH

Insp Date: 1/11/07 10:41 AM

Location Address: **2901 GUILFORD AVE**

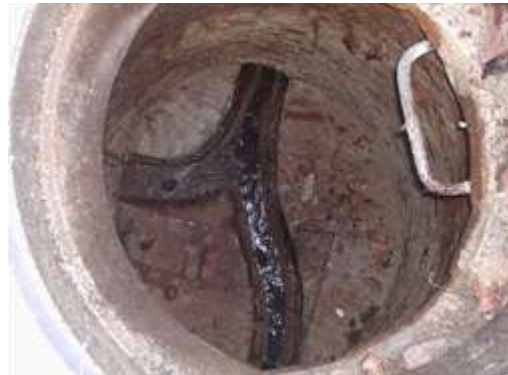
Top View

Bench and Channel debris.

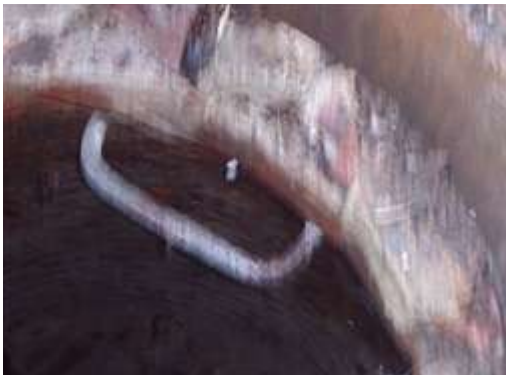
Defect

Frame Offset: **4** (in.) Condition: ☐ Sound ☐ Cracked ☒ **Leaks**

Condition: ☐ Sound ☐ Cracked ☐ Root Intrusion ☐ Loose Brick ☒ **Deteriorated**

Infiltration: ☐ None ☒ **Joint** ☐ Cracks ☐ Mortar ☐ Roots ☒ **Wall**

Frame leaks. Frame offset. Adjustment infiltration.

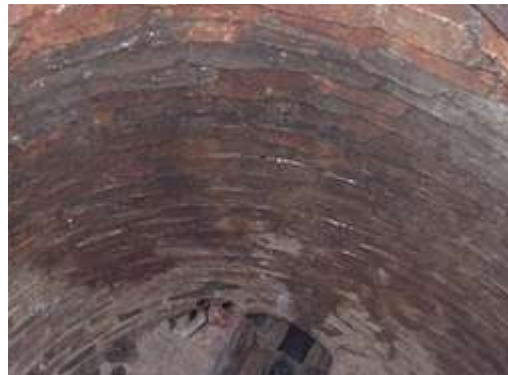
Defect

Frame leaks. Adjustment infiltration.

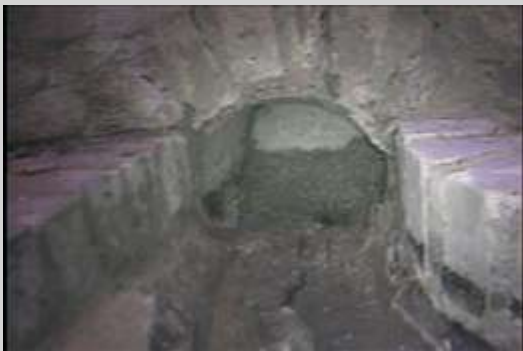
8 in. Circular Gravity Sewer
Pipe In @ 9 O'Clock

Capped.
